Step 1 - Remove Upper Trim Cap, Upper Bolt, Strike Support

Step 2 – Cut Body to Desired Length, Measure Along Narrow Edge, Re-Cut 9/16” Notch, Re-Drill Mounting Holes

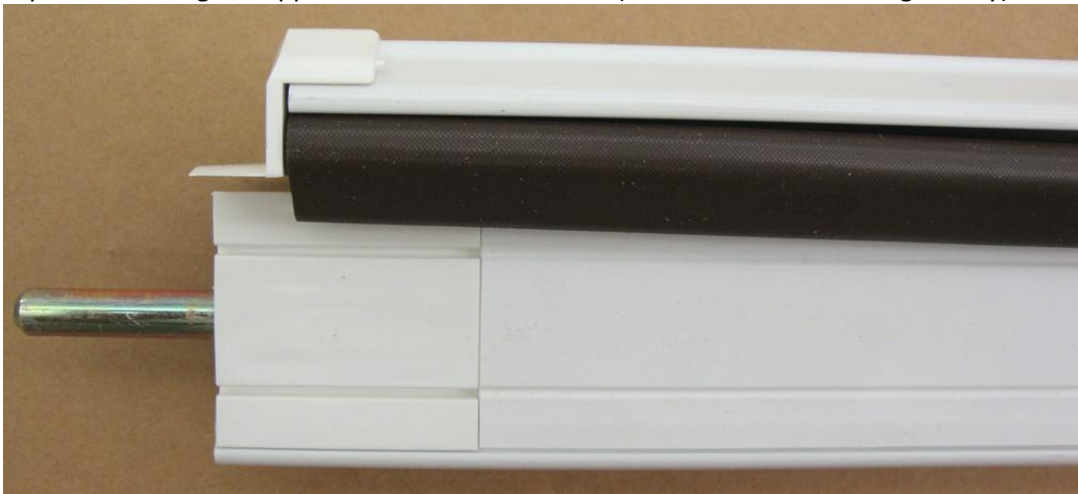
Top End of Astragal – Upper Bolt in Locked Position (Flush with End of Astragal Body)

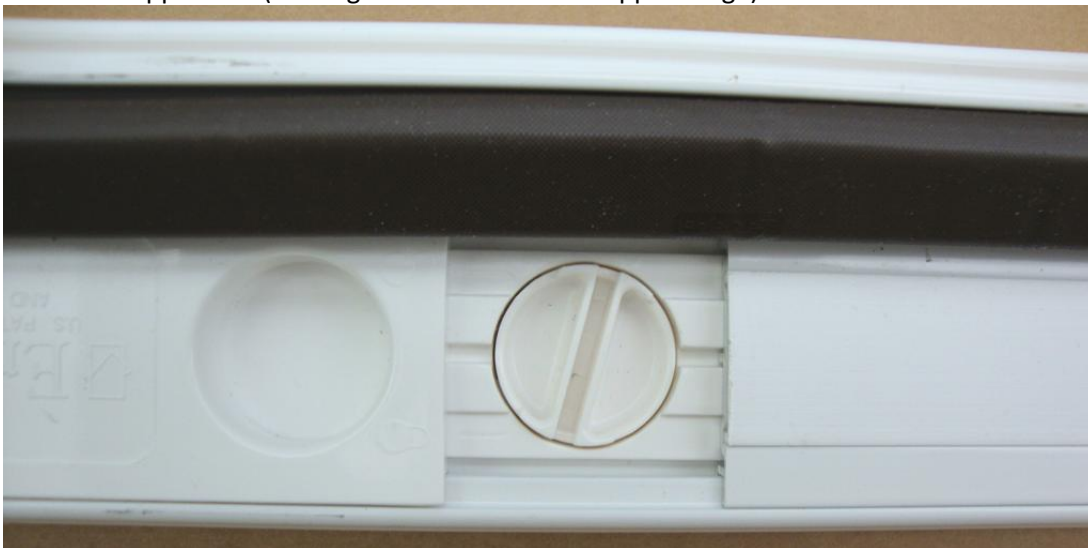
Bottom of Upper Bolt (Locking Knob Clears Strike Support Edge)

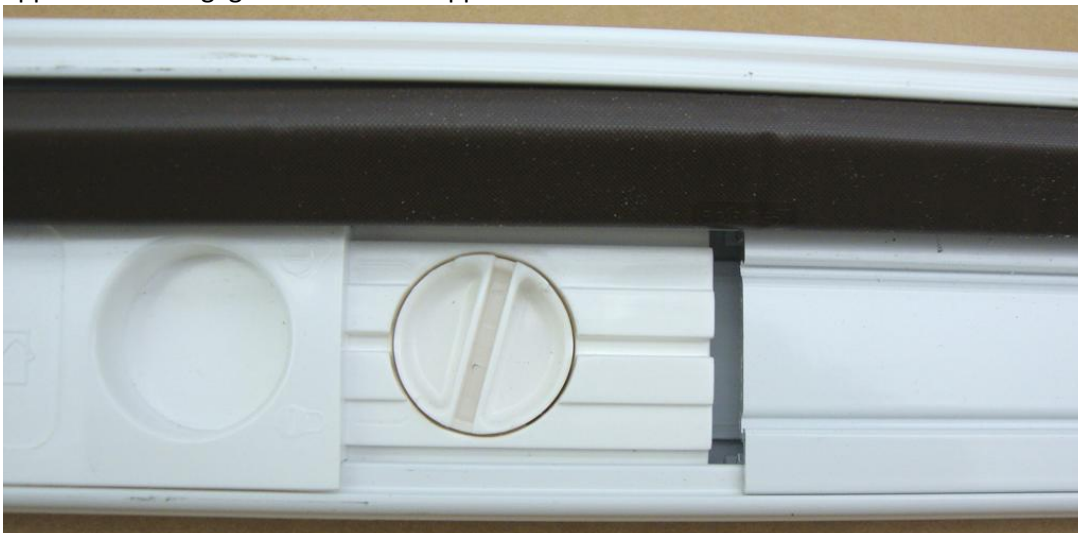
Upper Bolt Disengaged from Strike Support

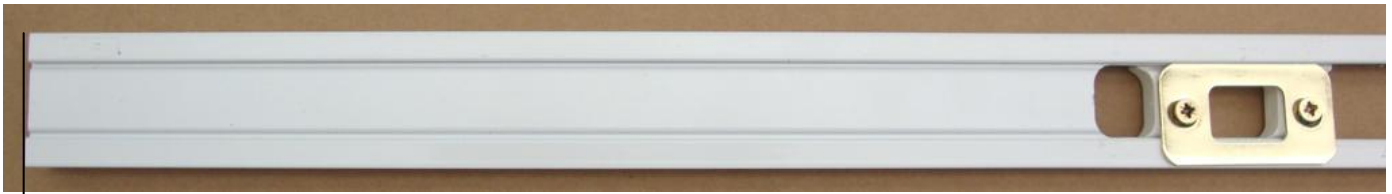
Step 3 – Cut Length of Strike Support by Same Amount as Astragal Body

Measure Length, Cut Down  
From Top End
